MAINTAINING POLAND'S HISTORIC PŁOCK BRIDGE

Poland's historic and architecturally important Płock Bridge has undergone its first ever total anti-corrosive refurbishment. Built in 1938, the fully-riveted bridge is an important crossing on the River Vistula. Purpose built to carry both road and rail traffic, it serves as one of the main commercial links between the north and south of Poland and was twice destroyed and rebuilt in its early years.

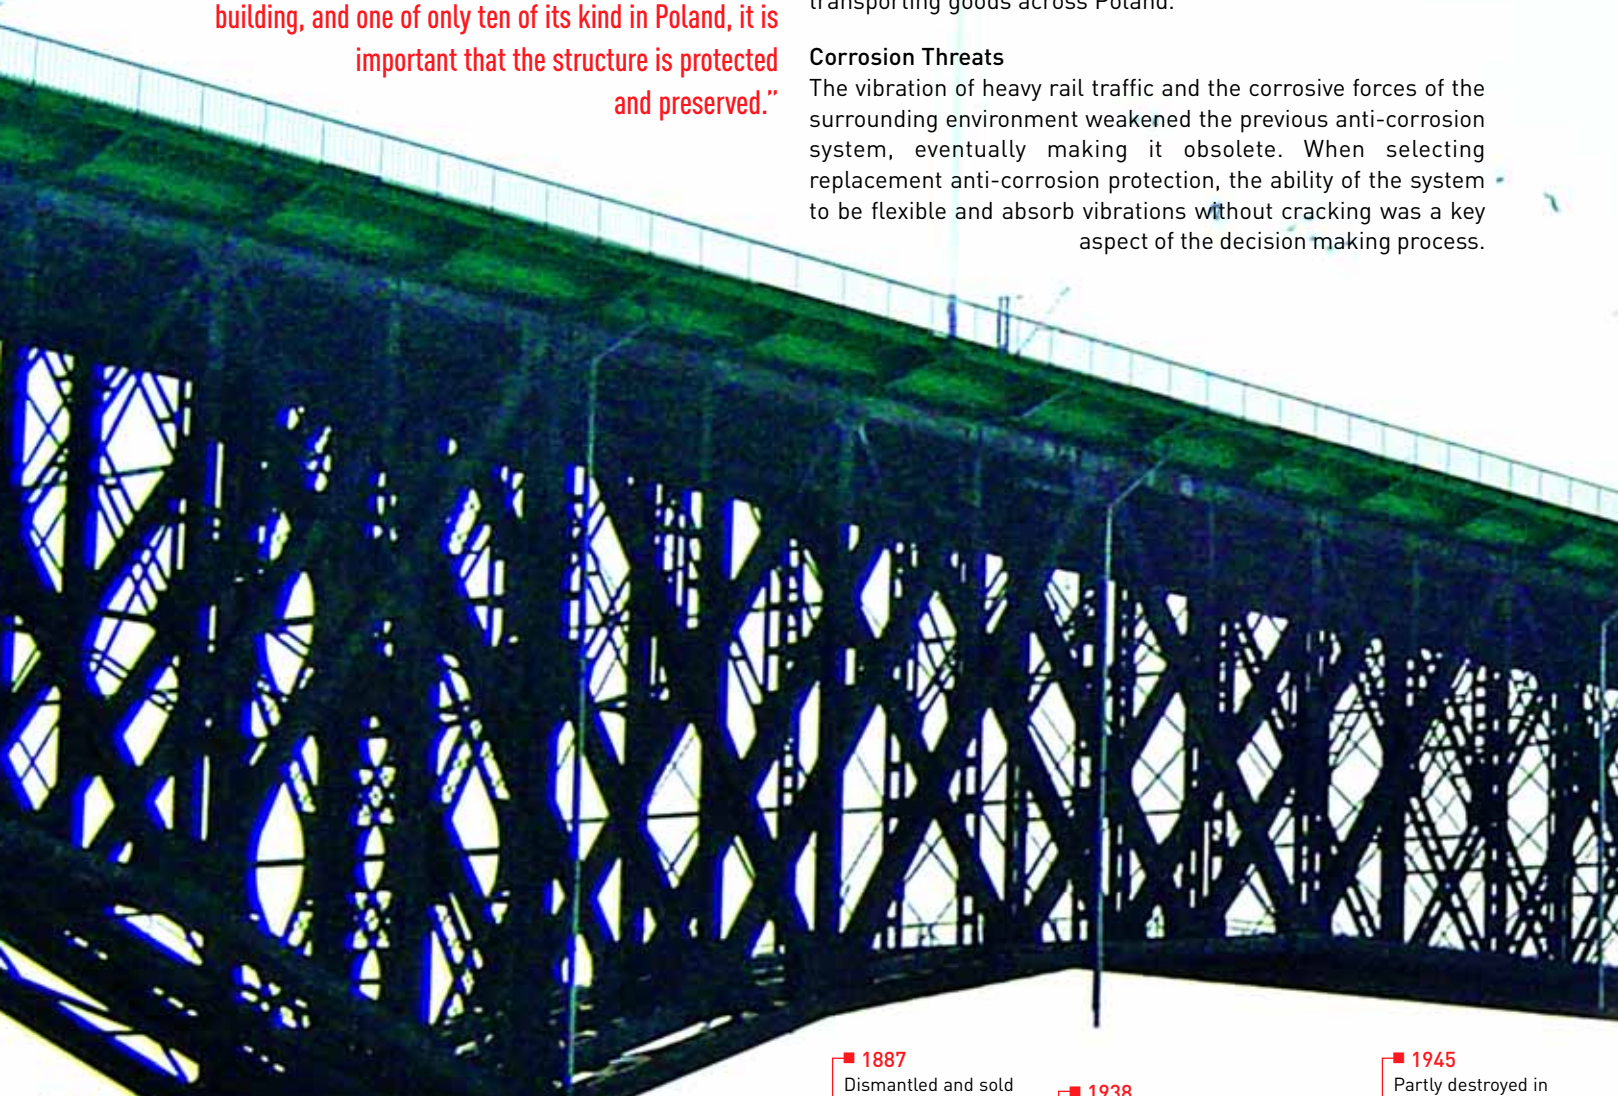
- The Płock bridge under maintenance. The new anti-corrosive coating is visible on the right hand side, colour matched to the bridge's original colour, with the aged coating on the left half of the structure.

A high performance system from International Protective Coatings, including an Interthane® finish, was eventually chosen as the best way to provide long-term protection for this important structure.

- Interthane provided a flexible top coat capable of resisting damage from the vibration of heavy loads moving across the bridge.
- Using International Protective Coatings' Chromascan® colour-mixing system, it was possible to choose a specific shade of topcoat to match the original colour of the bridge.
- International Protective Coatings' experienced technical service team were able to advise on the finer details, such as selecting a semi-gloss finish to hide any visual imperfections on the surface of the structural steel.

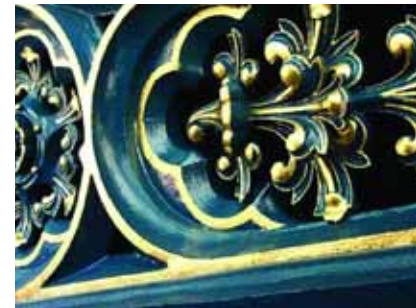
Trent Bridge, UK

Close-up view: gloss and colour durability far in excess of what was possible with traditional polyurethanes have been achieved in this maintenance project by using an Interfine® acrylic polysiloxane finish.
