# 40 years of performance

Hutton TLP case study  
and the impact of highly  
loaded lamellar glass  
flake in offshore coating

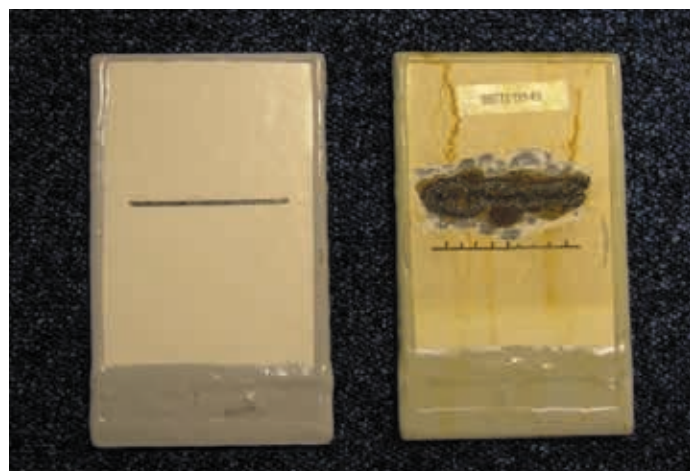
Figure 3 – Typical scribe testing

Accelerated corrosion tests such as ISO 12944 and Norsok M501 utilise corrosion creep at the scribe along with set pre-qualification criteria. These methods measure the performance once the coating has been artificially damaged and once the steel is exposed, it will start to corrode, and the coating's role is to slow down the expansion and spread of the corrosion due to under film corrosion.

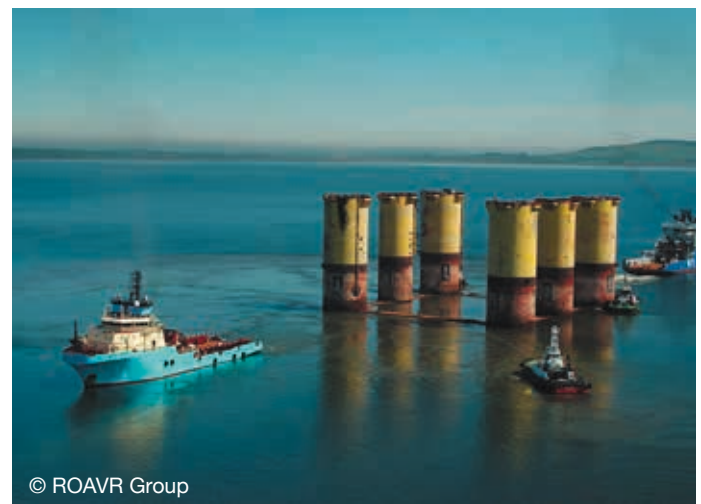
Figure 8 – Environmental zones on the Hutton TLP jacket.

The Hutton TLP jacket has 3 separate environmental zones including atmospheric and splash/tidal zones being protected by the coating system and the submerged zone which was protected using a combination of coating and sacrificial anode cathodic protection (SACP). Interestingly the submerged zone only had the full coating system applied to approximately 10 meters below the waterline.

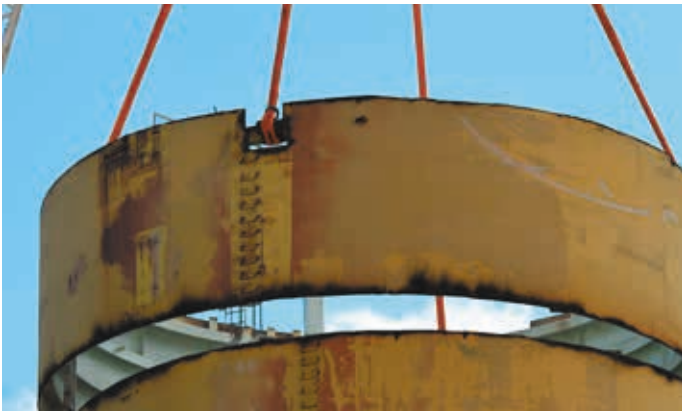
Figure 9 – Decommissioning process

In early 2022 we were approached by Nerida Limited who were responsible for the final decommissioning of the Hutton TLP jackets with regard to the coatings applied. During conversations with Nerida Limited it was agreed to provide test plates from the Hutton jacket for detailed inspection as to the condition of the coating system.

A coating inspection company was tasked with providing independent witnessing of the inspection of the coating system and provided a report [6] on the results which are discussed in detail below.

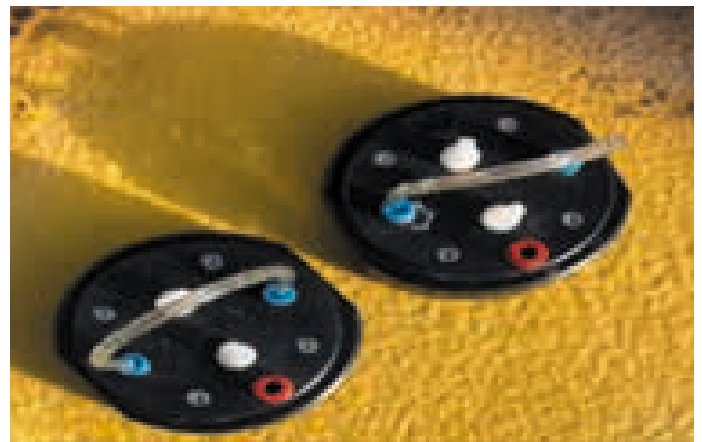
Figure 13 – EIS Contact Electrodes.

Electrochemical impedance spectroscopy (EIS) can be used as a non-destructive technique to determine a coating's barrier properties and potentially indicate substrate corrosion processes under the film. Intact coating locations (each with an area 12.55 cm<sup>2</sup>) were measured to assess the barrier properties that are representative of the overall bulk coating. EIS measurements<sup>[8]</sup> were performed using a sinusoidal signal of 200 mV applied at open circuit potential in the frequency range 10,000 – 1 Hz. As the EIS measurements<sup>8</sup> were carried out in the field, values were obtained using a two-electrode system, in which the working electrode is the coated steel substrate, and the counter electrode is a stainless-steel

casing in a 3.5 wt.% NaCl(aq) electrolyte which is kept in contact with the measurement area (12.55 cm<sup>2</sup>) using a magnetic cell (Figure 13). The electrodes were attached to the test plate for 48 hours to ensure total saturation of the sample area prior to scanning.
